REC'D 6-19-87  
FB.RCRA RECORDS CENTER  
FACILITY Ciba Geigy Corp  
ID. NO. RID001194323  
FILE LOC. R-5  
OTHER \_\_\_\_\_VISUAL SITE INSPECTION REPORT  
RCRA FACILITY ASSESSMENT  
CIBA-GEIGY CORPORATION  
CRANSTON, RHODE ISLAND

U.S. ENVIRONMENTAL PROTECTION AGENCY  
Office of Waste Programs Enforcement  
Washington, D.C. 20460

Work Assignment No.	:	265
EPA Region	:	I
Facility ID No.	:	RID001194323
Date Prepared	:	June 11, 1987
Contract No.	:	68-01-7331
CDM Federal Programs	:	
Corporation Document No.	:	T265-R01-RT-AQXF-3
Prepared By	:	Versar
Work Assignment Project Manager	:	Dennis Giestra
Telephone Number	:	(703) 750-3000
Primary Contact	:	Frank Battaglia
Telephone Number	:	(617) 223-1961

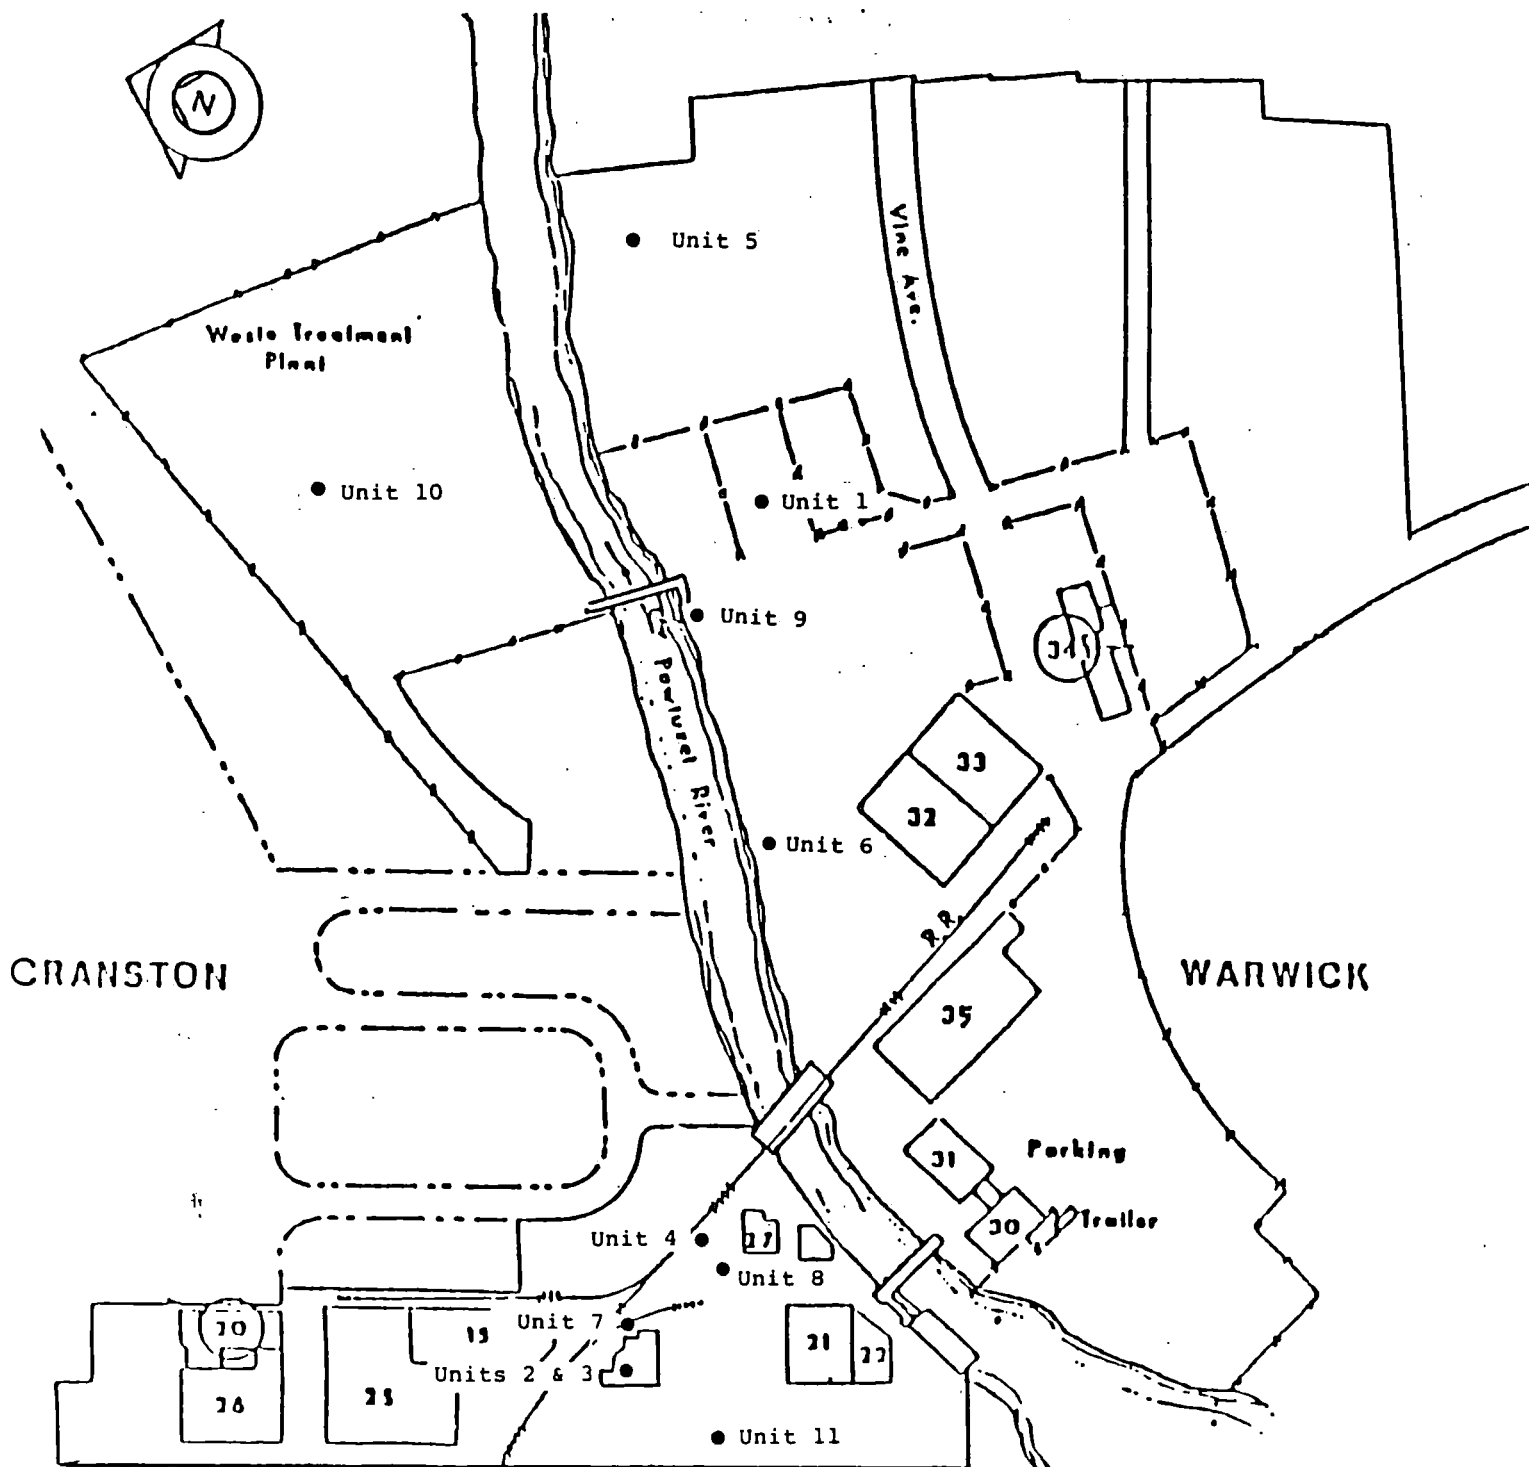
FIGURE 2  
 SOLID WASTE MANAGEMENT UNITS  
 CIBA-GEIGY CORPORATION, CRANSTON, RHODE ISLAND  
 (CIBA-GEIGY, 1985)

During the VSI, all SWMUs previously identified by Ciba-Geigy were located and examined (Figure 2). Updated information for each unit will be presented in this section. No additional SWMUs were identified but other areas of concern were examined.
